Characterization of the rammed-earth structure of the Moon Castle in Mairena del Alcor (Seville, Spain)

ABSTRACT: In February 2008, in the laboratories of Vorsevi S.A., a series of analyses and tests were conducted on the rammed-earth walls, towers, and sections of barbican walls of the Moon Castle in Mairena del Alcor (Seville, Spain) in order to characterize the constituent material and to collect data that would enable the valuation and quantification of the future actions to consolidate the walls. Data related to the particle size and the physical, mechanical and chemical characteristics were provided, and information was obtained pertaining to the composition, conservation, and behavior of the wall when faced with consolidation and waterproofing treatments. These treatments form the basis of the consolidation and reinforcement techniques which, in these pages, are referred to as the most appropriate for these walls.

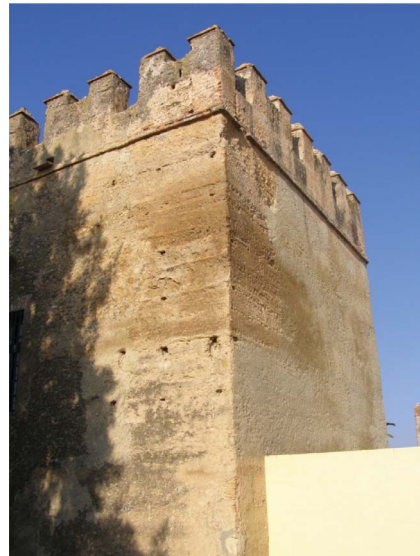
Figure 2. Bell tower.

In both stages, walls were constructed with rammed earth (Fig. 2) of diverse typology, which nowadays can be observed as having been greatly altered by successive consolidation work throughout its history, but especially by those interventions carried out in the early twentieth century by the English archaeologist George Bonsor (1822–1930) who bought the castle and set up his residence there.

Two of the four towers, which flank the southern front, that is, the SE tower (the Bell or Chapel tower) and the SW tower (Mocha Tower), were constructed in simple rammed earth, that is to say, the courses of the rammed-earth boxes were placed directly upon each other, thereby generating monolithic structures which lack both intermediate elements and vertical links.

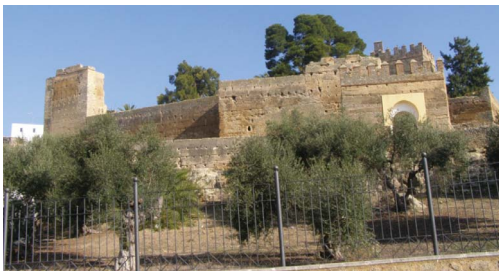
Figure 1. View of the castle.

The Moon Castle in Mairena del Alcor, Seville (Spain), whose first stages were built in the mid-fourteenth century and later completed and refurbished in the second half of the fifteenth, is not only one of the most important castles of the province, but also constitutes one of its civil buildings of greatest magnitude constructed in rammed earth (Fig. 1).

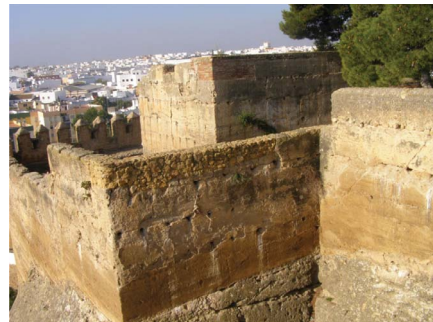
Figure 4. South barbican.

In the composition of the walls, abundant use of “albero” is observed; the typical ochre sedimentary rock of this zone, rich in calcite, poor in quartz and with a variable content of iron oxides in the form of goethite (Fig. 4). This material has been widely used in construction in Seville, since it gives mortars the good qualities of high mechanical strength and a low reduction in volume.

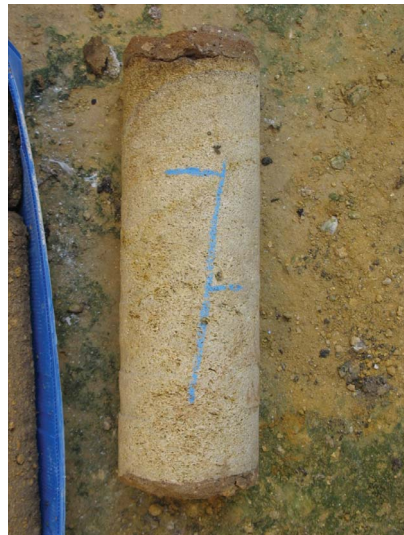
Figure 7. Sample 7.

In the case of samples number 7 (ruined tower, Fig. 7) and 10 (south barbican) sandstone samples were extracted.

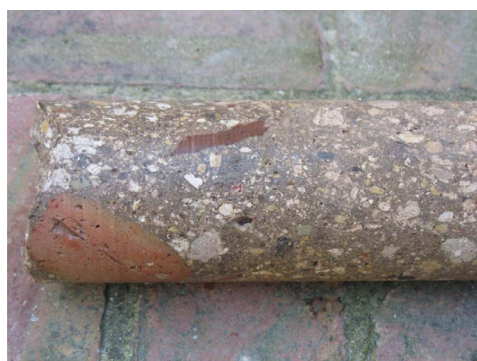
Figure 8. Sample 1.

Granulometry tests were done in order to detect fractions of sand, gravel and clay contained in the *tapia* samples, obtaining a maximum aggregate size exceeding 40 mm in sample 2, and lower in the

rest, and detecting a 80–90% of sand, containing a higher quantity of silts and clays than 10% in all samples except for No. 1 (Fig. 8).
