Preliminary studies for intervention, interpretation and value enhancement of Tower of Don Fadrique (Albaida, Seville, Spain)

A. Graciani, J.J. Martín, G.M. Mora, F.J. Alejandro & J. Canivell

Seville University, Seville, Spain

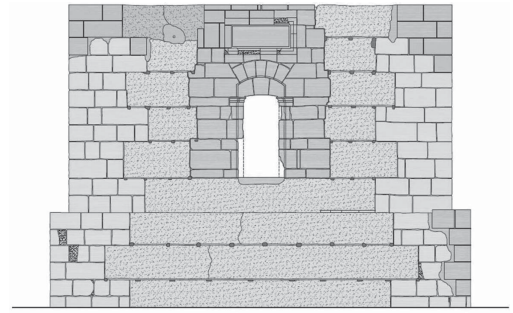
Figure 1. NW face of the tower (L.A. Núñez Arce).

The most interesting sides of the tower are the NW (Fig. 1) and the SW face, where appear the main elements contributing to clarify the tower's origin.

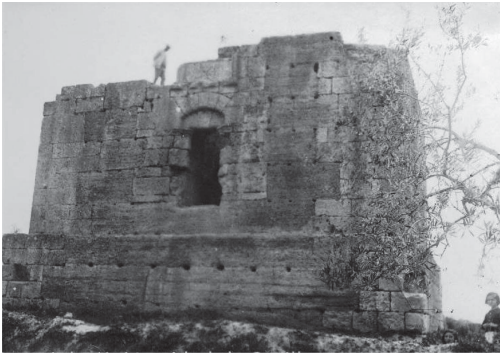
Figure 2. Image from the 1930s (Photography Library of the Art Laboratory of the University of Seville).

The original Almohad building was raised at the start of the 13th century. It was attached to a walled recinct of which we have found no remains to date. However, we have traced its existence in the course of our research. In fact, images from the 1930s preserved at the Photography Library of the Art Laboratory of the University of Seville (Fig. 2), allow us to refute previous hypotheses and confirm that the Torre Mocha was not a guard tower or a Fort Tower (Ortiz de Zúñiga 1975) in contrast to the San Antonio Tower, a nearby coeval building.

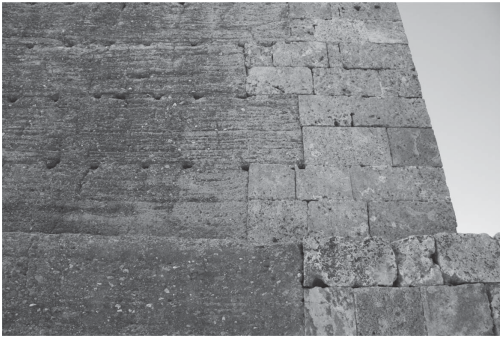
Figure 3. NW wall of the tower (A. Graciani).

The tower was built of mixed rammed-earth and stone masonry (Fig. 3). The chain was carried out with coursed ashlar of local stone and some pieces were re-used. The courses have a height ranging between 0.88 to 0.90 m and are separated by a 0.03 m thick layer of lime. It is executed with overlapping formworks creating 6–7 meter sections of continuous rammed earth between the stone chains. Its NW face, towards the plain, must have housed its original entry point, of which there is currently no evidence.

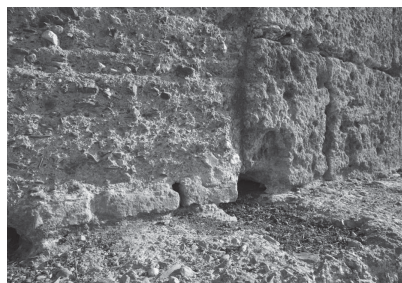
Figure 4. NW face of the tower (detail) (A. Graciani).

Material damage is more evident and is due to erosion (especially bad in the topmost courses lacking adequate roofing). The surface loss of mass overall in the walls is significant, with a consequent exposure of the lime mortar layer between courses; however, it can be classified as of slight importance due only to the highly cohesive mortar resulting from the high-quality execution and the high proportion of lime.

However, there is a certain trend to higher hazard in material damage (erosion), evidenced by a somewhat higher hazard level due to the lack of protec-

tion (roof and covering), to the high exposure, and to the lack of regular maintenance. Therefore, it is advisable to apply certain preventative measures in the medium or short term to reduce the hazard of existing erosion progressing. Otherwise, what is currently superficial loss of mass and stains could degenerate with a certain degree of probability into more serious damage.
