Characterization of the rammed-earth structure of the Moon Castle in Mairena del Alcor (Seville, Spain)

ABSTRACT: In February 2008, in the laboratories of Vorsevi S.A., a series of analyses and tests were conducted on the rammed-earth walls, towers, and sections of barbican walls of the Moon Castle in Mairena del Alcor (Seville, Spain) in order to characterize the constituent material and to collect data that would enable the valuation and quantification of the future actions to consolidate the walls. Data related to the particle size and the physical, mechanical and chemical characteristics were provided, and information was obtained pertaining to the composition, conservation, and behavior of the wall when faced with consolidation and waterproofing treatments. These treatments form the basis of the consolidation and reinforcement techniques which, in these pages, are referred to as the most appropriate for these walls.

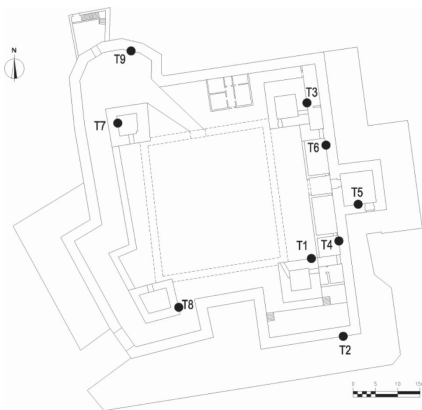
Figure 5. Location of samples.

Samples were taken from the walls, towers and from the Barbican (Fig. 5), and conducted the tests listed below.

n°		
1	Bell tower. North wall	Outside
2	Barbican southeast	Outside
3	Duque tower east	Outside
4	Barbican east	Inside
5	Office	Inside
6	Dining room	Inside
7	Torre Southeast	Inside
8	Mocha Tower	Outside
9	Barbican Northeast	Outside
10	Barbican south.	Outside

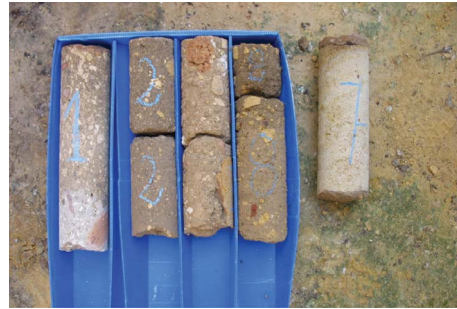
Figure 6. Samples.

In order to obtain its composition, ten samples (Figure 6) were taken in the four towers and the barbican, in the more representative walls, numbered and located as following:

The samples extracted were mostly of *tapia* with different aggregate: sand and gravel, pieces of ceramic material, clay, silt and lime, and abundant “albero”, easily found on site.
